ADVANCED COMPOSITE ELEVATOR FOR BOEING 727 AIRCRAFT VOLUME 2—FINAL REPORT

Boeing Commercial Airplane Company
P.O. Box 3707, Seattle, WA 98124

CONTRACT NAS1-14952
NOVEMBER 1980

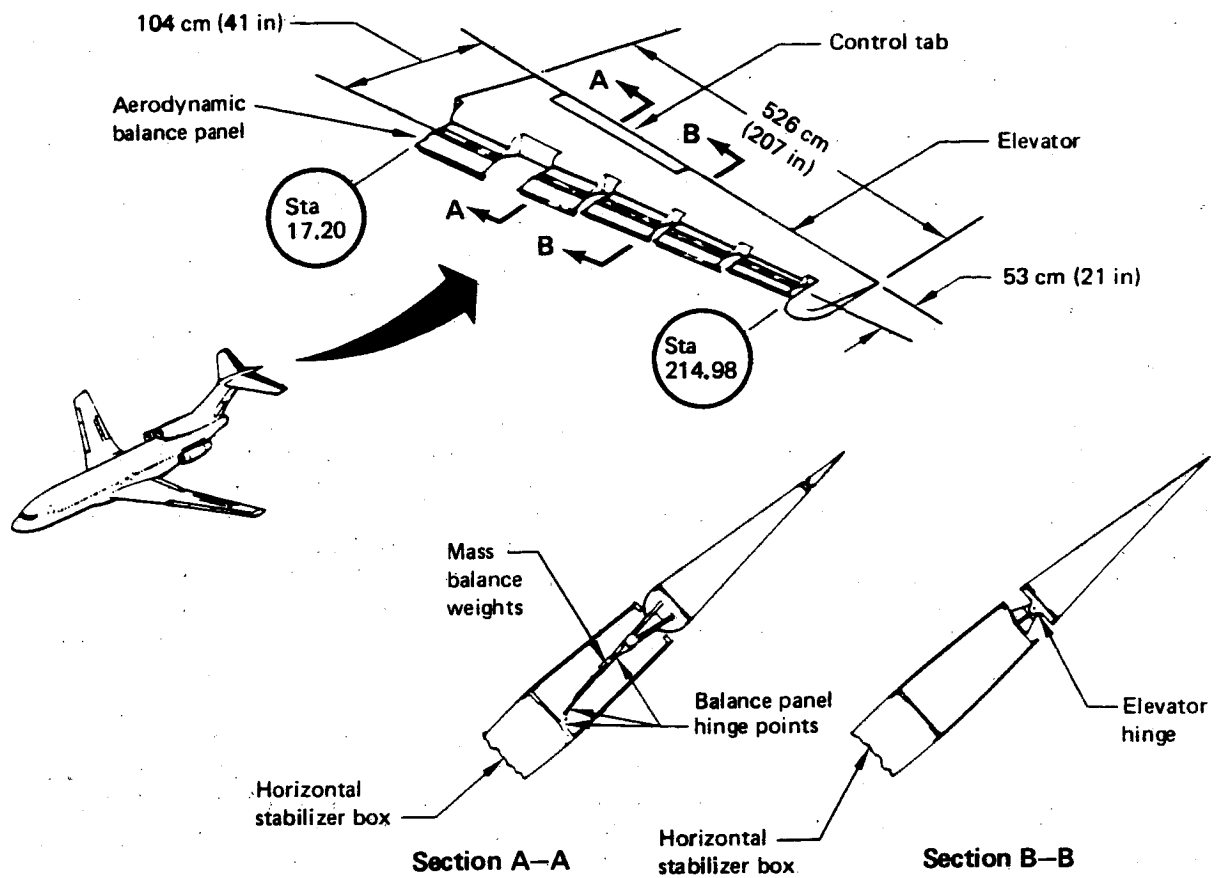
Figure 1. 727 Elevator General Arrangement

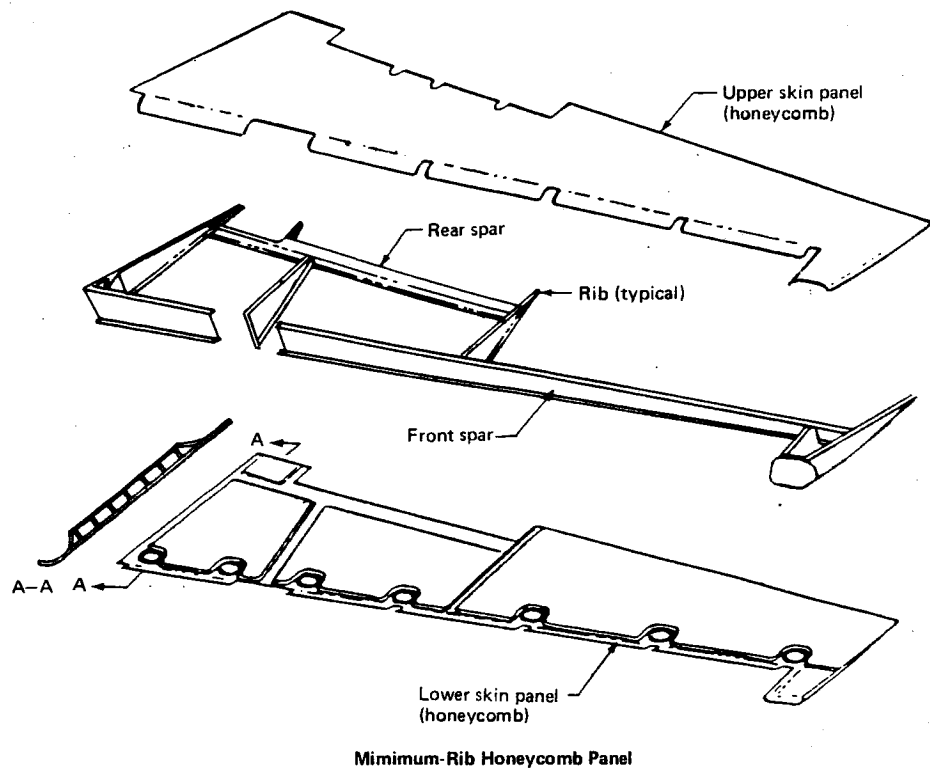
Figure 3. Preliminary Composite Elevator Configuration—Concept 1

Four replacement preliminary composite elevator configurations (figs. 3 through 6) were considered. Concept 1 utilized a minimum number of ribs and skin panels stabilized by Nomex honeycomb core (fig. 3). This concept had been previously used in Boeing transport fiberglass control surfaces. A minimum thickness, solid laminate skin, supported by closely spaced ribs, was considered in Concept 2 (fig. 4). This design had been developed in composite control surfaces. Concepts 3 and 4 (figs. 5 and 6) used the same number of ribs as in the existing metal elevator with solid laminate skin panels stabilized by bead stiffeners and blade stiffeners. These two configurations were considered because they closely matched the existing aluminum elevator configuration.

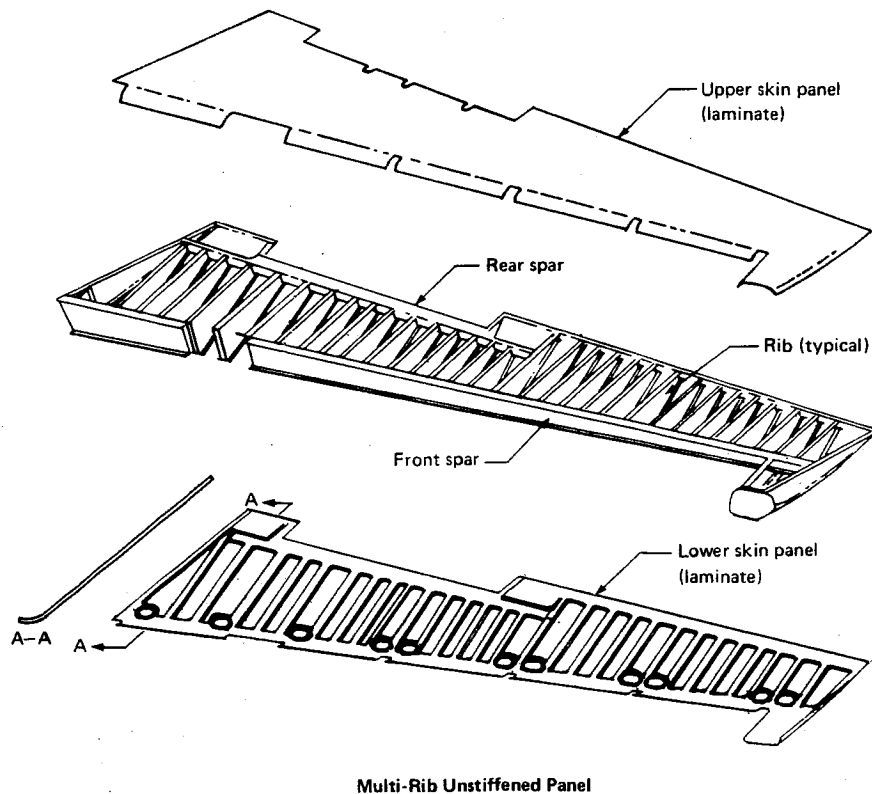
Figure 4. Preliminary Composite Elevator Configuration—Concept 2

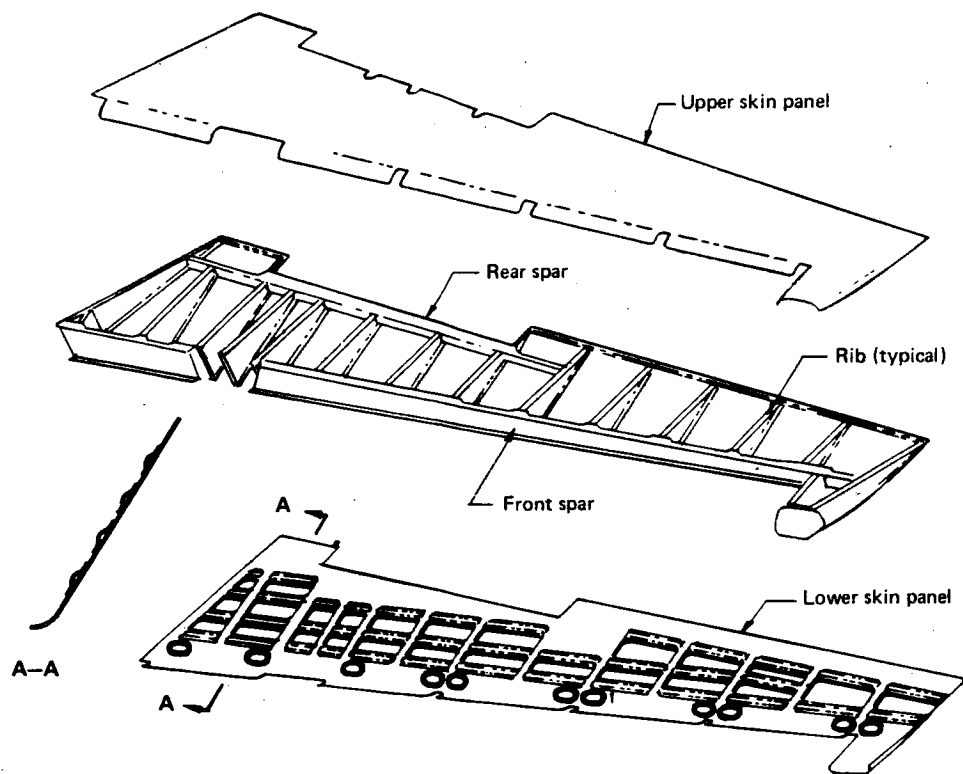
Figure 5. Preliminary Bead-Stiffened Panel Composite Elevator Configuration—Concept 3

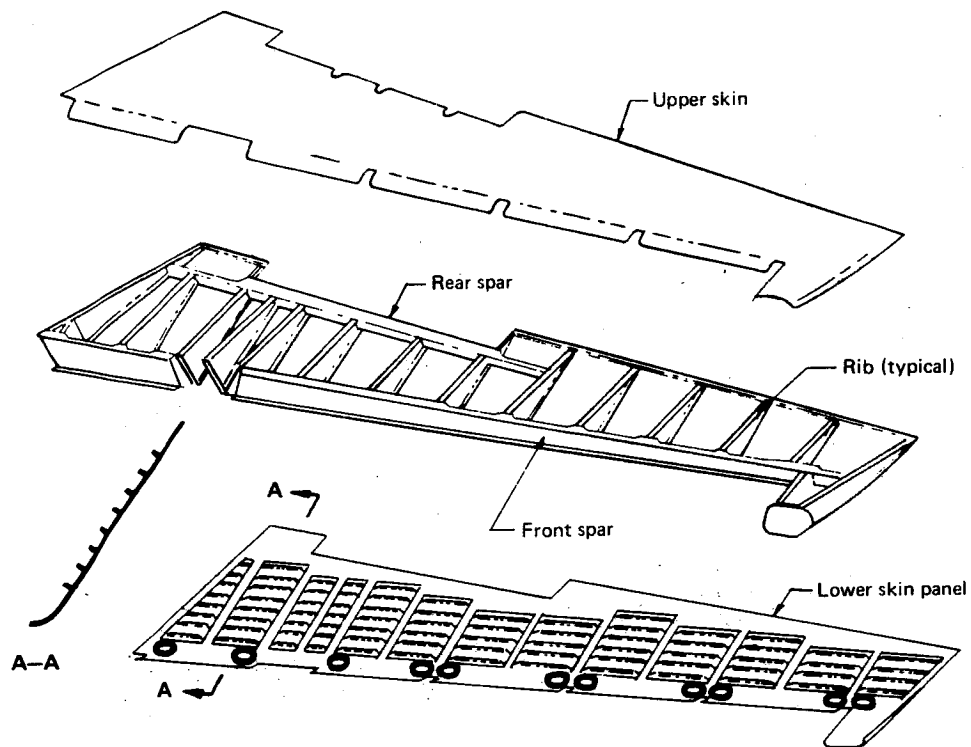
Figure 6. Preliminary Blade-Stiffened Panel Composite Elevator Configuration—Concept 4

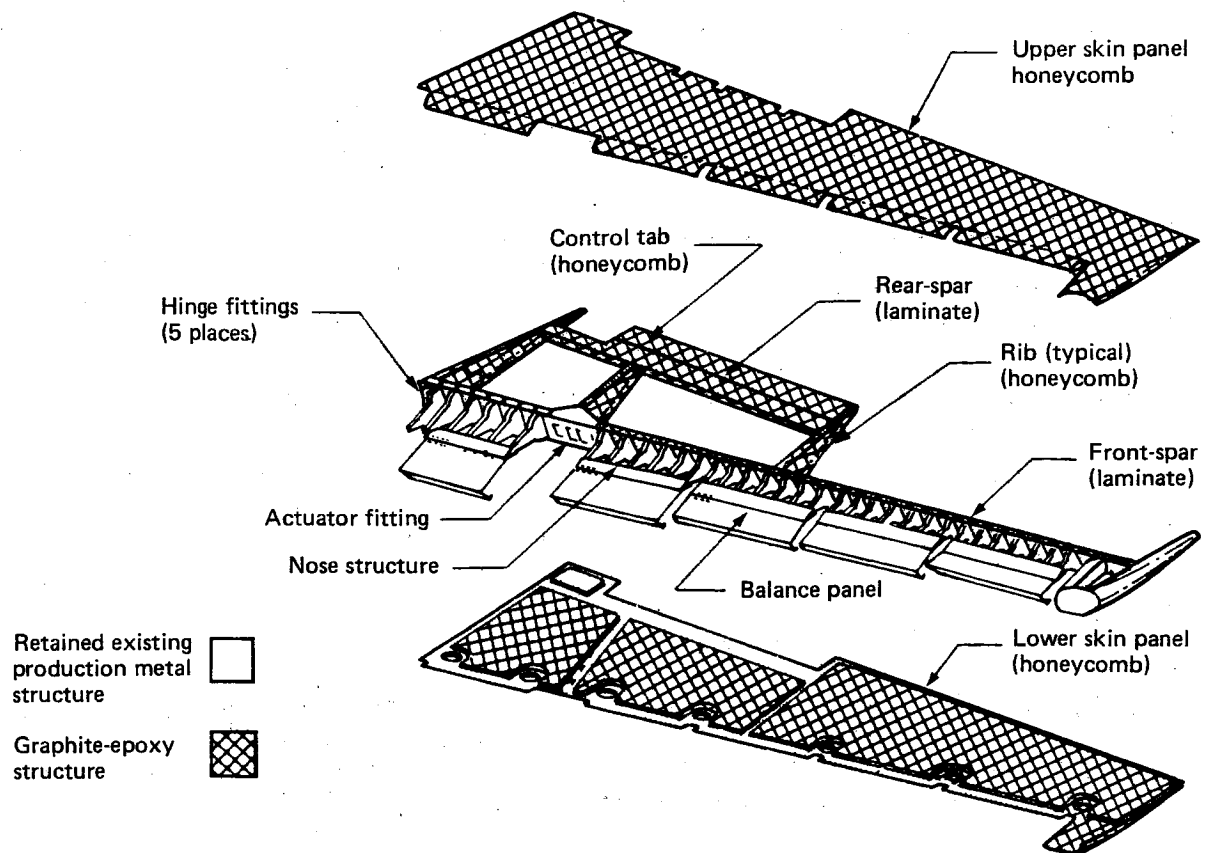
Figure 7. 727 Composite Elevator Structural Arrangement

The composite elevator configuration selected (Concept 1) is shown in Figure 7. This design features one-piece lightweight honeycomb upper and lower skin panels, a laminate front spar spliced at the actuator fitting, a laminate rear spar from the elevator tab inboard, and a minimum number of honeycomb ribs.

The existing production metal nose structure (consisting of nose ribs, nose skins, and aerodynamic balance panels) was retained with little or no change, as shown in Figure 7.

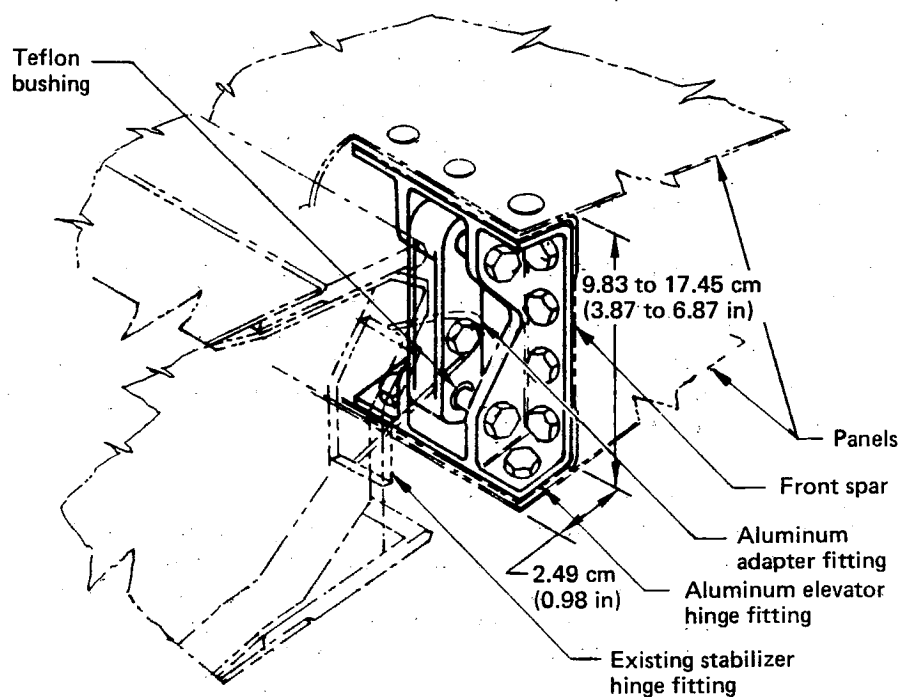
Figure 8. Sliding Block Hinge Fitting

- The second concept introduced an adapter fitting that retained the existing hinge pin by providing lugs identical to the existing elevator hinge fitting and transferring the spanwise motion to bolts that were mounted in teflon bushings above and below the hinge point. See Figure 8 for configuration details.

Mockups were made of each of these configurations for detailed evaluation of access, producibility, and maintainability. This evaluation led to the selection of the concept that incorporates the adapter fitting (fig. 8). This concept permits considerably better access for elevator installation and/or removal and avoids the use of a special high-heat-treat hinge steel bolt at the point of interface with the stabilizer.

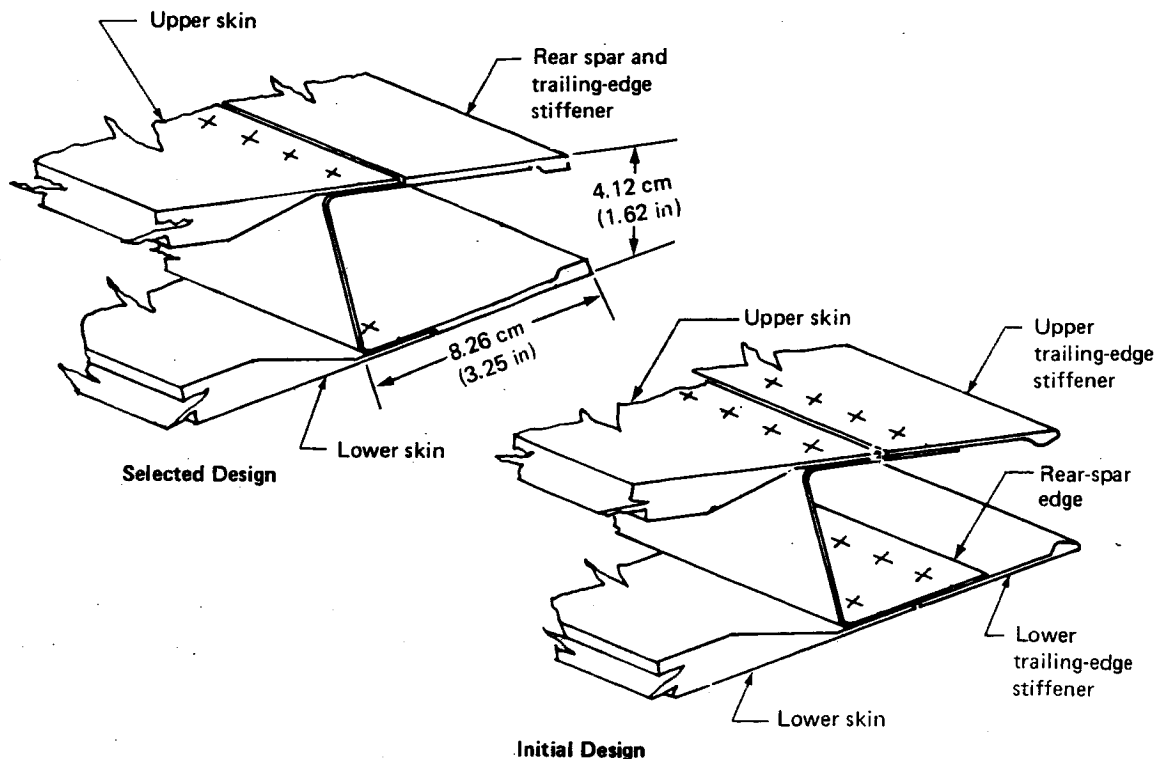
Figure 9. Rear-Spar Trailing Edge

A study was made of the attachment of the rear-spar trailing-edge stiffener to the rear spar. The initial design (fig. 9) of the rear-spar trailing-edge stiffener had one row of fasteners attaching it to the rear spar. An alternative to this design was to make the trailing-edge stiffener integral with the rear spar, thereby eliminating the weight and installation cost of the fasteners and additional separate parts. The complexity of the rear spar tooling and fabrication would be increased with integral parts. The selected design was integral trailing-edge stiffeners instead of separate trailing-edge stiffeners similar to those used on the existing aluminum elevator.

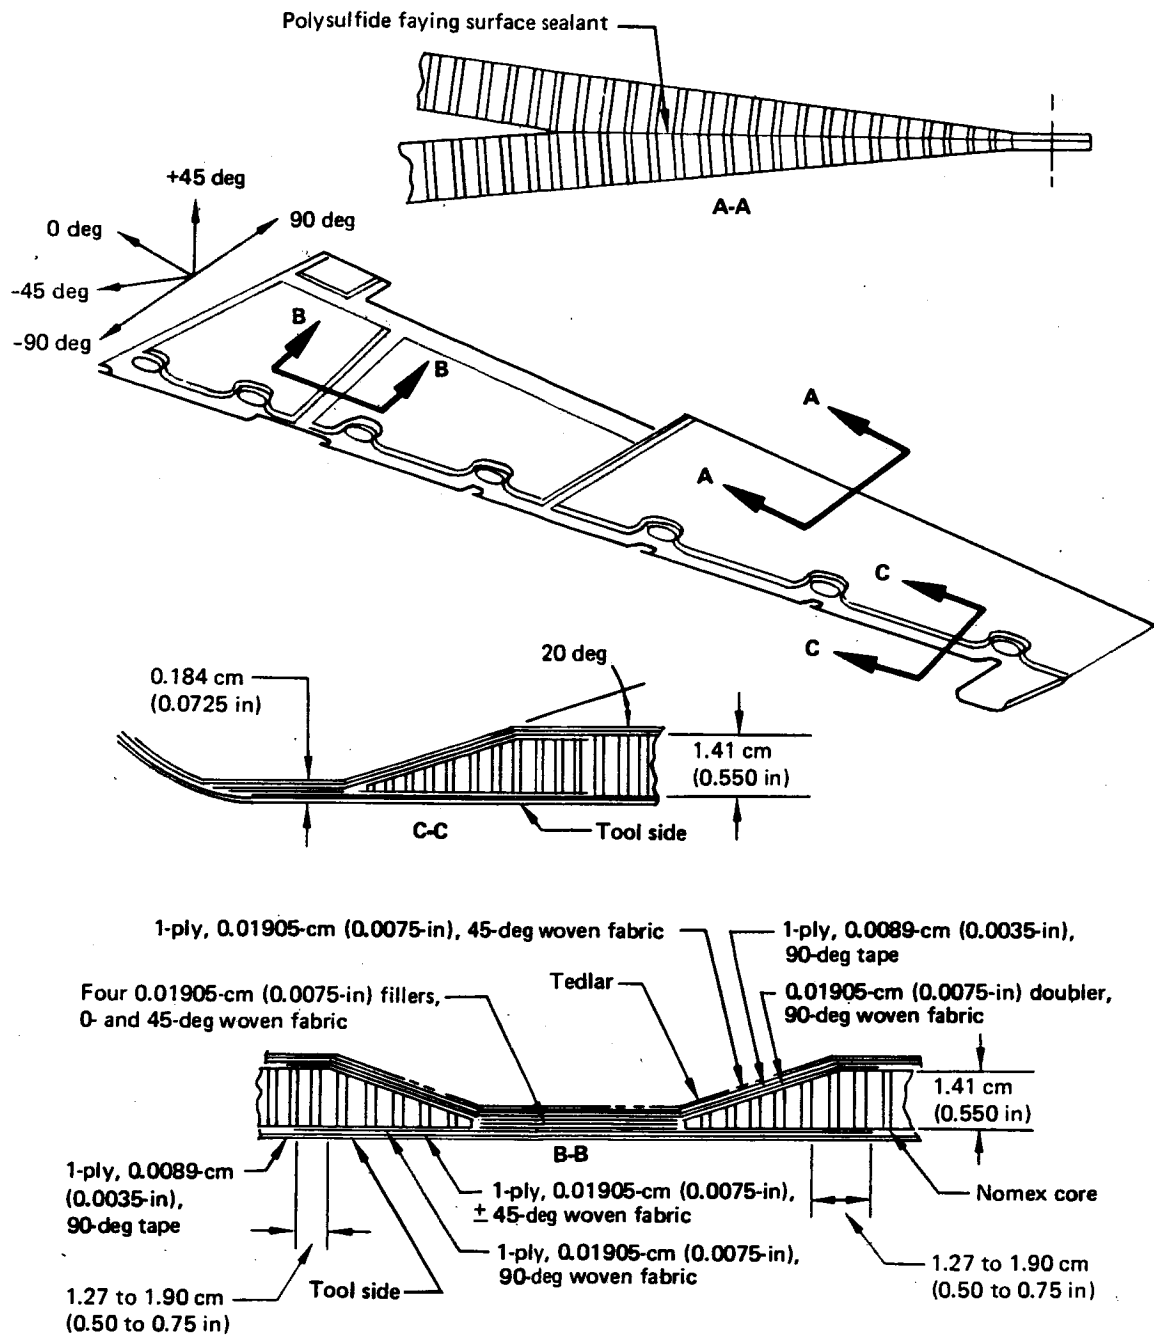
Figure 10. Elevator Skin Panel

The basic panel was designed to provide torsional stiffness equivalent to the existing aluminum panel and to carry the air pressure load without excessive deflection. A solid laminate for fastener attachment was provided along the front spar, trailing edge, rear spar, ribs, and around cutouts. Figure 10 shows the skin panel details. Before selecting the layup configuration, several candidate layups were evaluated after fabrication of sample panels. The evaluation emphasized minimizing weight, layup time, exterior surface roughness to reduce finishing time, fiber breakout on exit side of holes, and panel warpage. An evaluation summary of the other candidate panel layups follows:

The skin panels were riveted together along the trailing edge, using special harness-type double-countersunk titanium rivets that were squeeze installed. Polysulfide sealant (BMS 5-79) was used as a faying-surface sealant in this area (fig. 10).

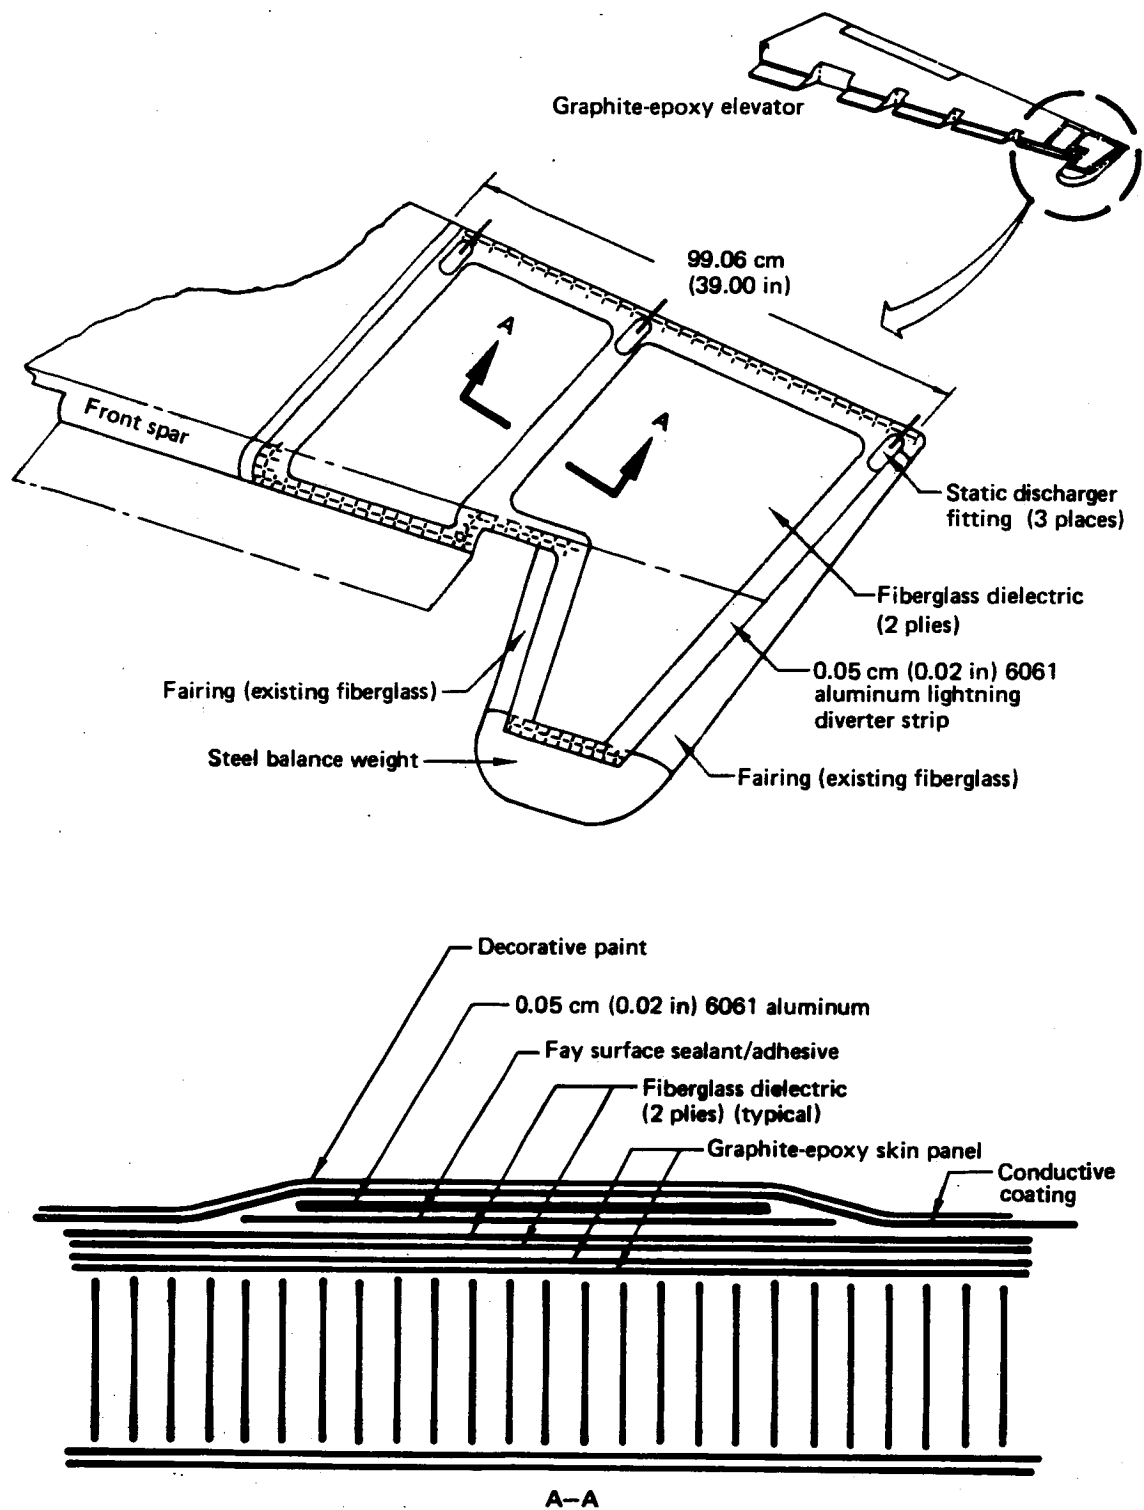
Figure 11. Lightning Protection System

The lightning protection system consists of an aluminum diverter strip separated from the graphite-epoxy elevator skin panel by a two-ply fiberglass dielectric layer. This system is shown in Figure 11. The aluminum diverter strips are electrically bonded to the aluminum nose skins and thus provide an electrical path in the aluminum horizontal stabilizer box. These aluminum diverter strips serve as a point of attachment for the initial lightning bolt, as well as conducting the longer term (up to 1 s) lightning current component. This lightning protection system is designed to withstand a severe lightning strike of 100,000A peak current without sustaining significant damage.

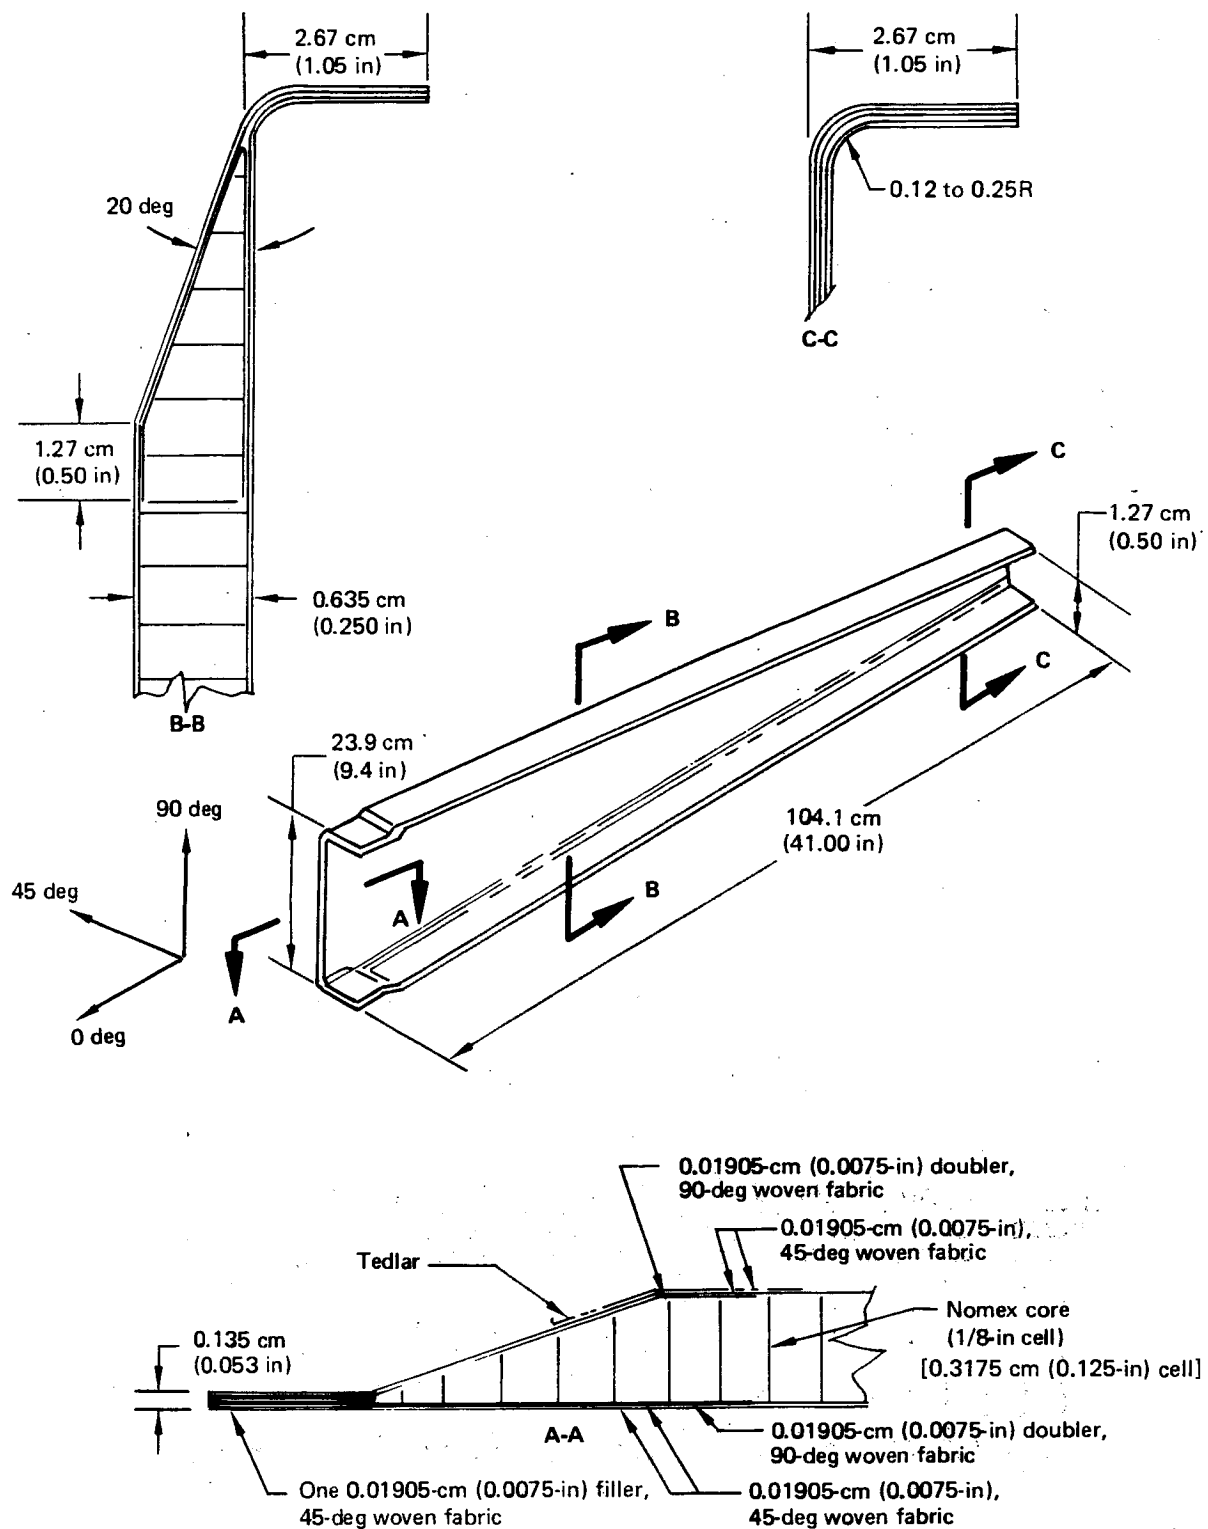
Figure 12. Graphite-Epoxy Honeycomb Rib

The four major ribs (inboard closure, actuator backup, station 117, and outboard closure) in the selected elevator design are honeycomb ribs. The rib configuration and layup are defined in Figure 12. Before selecting this concept, a trade study was made comparing a honeycomb rib with a sine-wave rib. Parts of each configuration were designed and fabricated. The ribs were of equal weight; however, it took longer to lay up the sine-wave configuration than the honeycomb configuration. Section 5.1.1.1 presents further details.

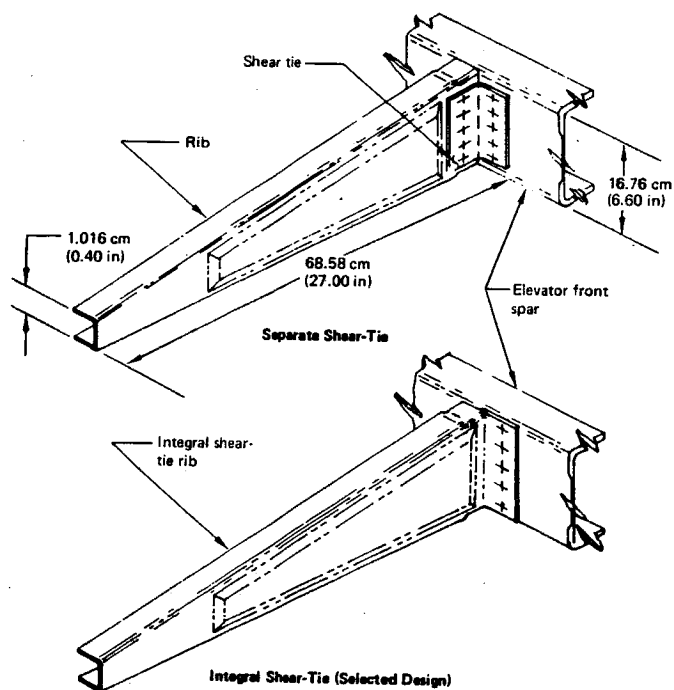
Figure 13. Rib at Station 117.36

The rib at station 117.36 was designed to incorporate the shear-tie angle as an integral part of the rib, thus eliminating the separate shear-tie angle and one row of fasteners. Alternate designs are shown in Figure 13. One concern of the integral design lies in the mismatch that could occur between the spar and rib heights. Any mismatch in the surface contour normally would be compensated for by moving the rib toward or away from the front spar before attaching the separate shear tie. This adjustment is impossible with an integral shear tie. Contour mismatch did not prove to be a problem.

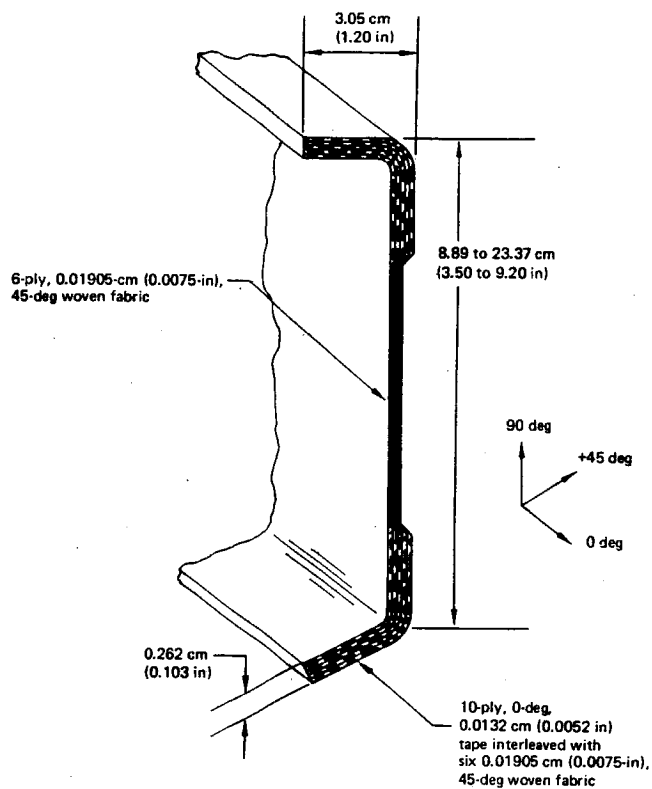
Figure 14. Front Spar

The front spar is made in two sections and spliced by the actuator fitting. Both sections are channel-shaped laminates laid up on male tools. These spars are spliced by the actuator fitting. The layup consists of 6 plies of +45-deg fabric with up to 10 plies of 0.0132-cm (0.0052-in) thick unidirectional tape interleaved with the fabric in the chord areas (fig. 14). An unstiffened laminate spar section was selected because the stiffeners required for the 33 nose rib attachments plus the hinge fittings provide all the stiffening required. The chords were designed to furnish the necessary bending stiffness, and the web was designed to carry the shear load.

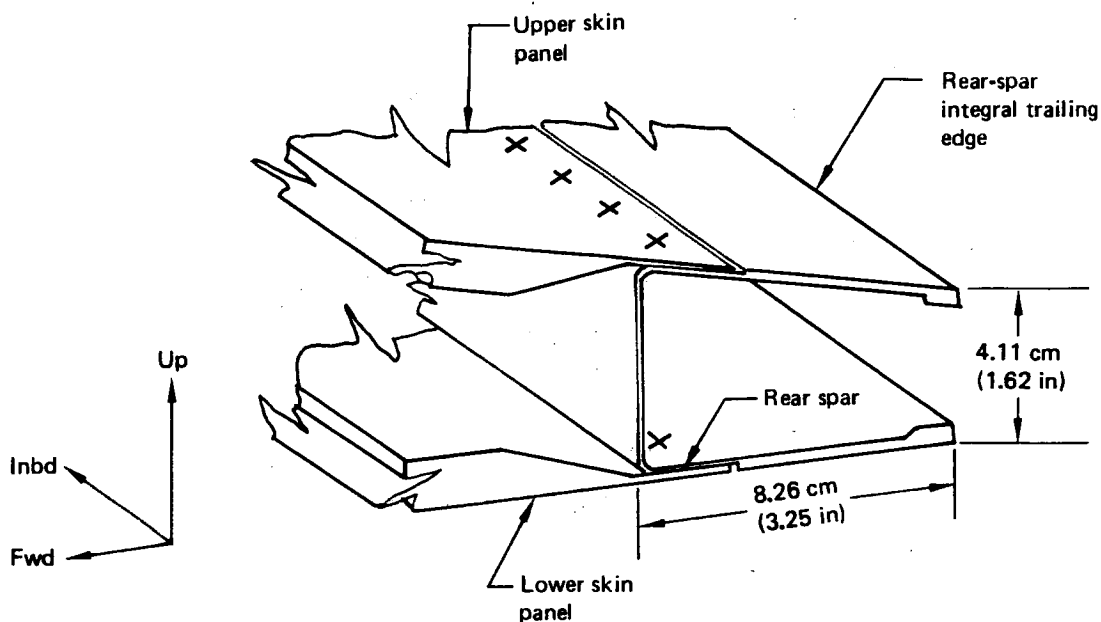
Figure 15. Rear Spar

The rear spar is a channel-shaped laminate, as indicated in Figure 15. This spar ends at the outboard end of the tab and supports the five tab hinge fittings and the aft edge of the elevator panels. The layup is four plies of 0.01905-cm (0.0075-in) thick fabric, with fibers at +45 and -45 deg interleaved with two to three plies (depending on location) of 0.01905-cm (0.0075-in) thick fabric with fibers at 0 and 90 deg.

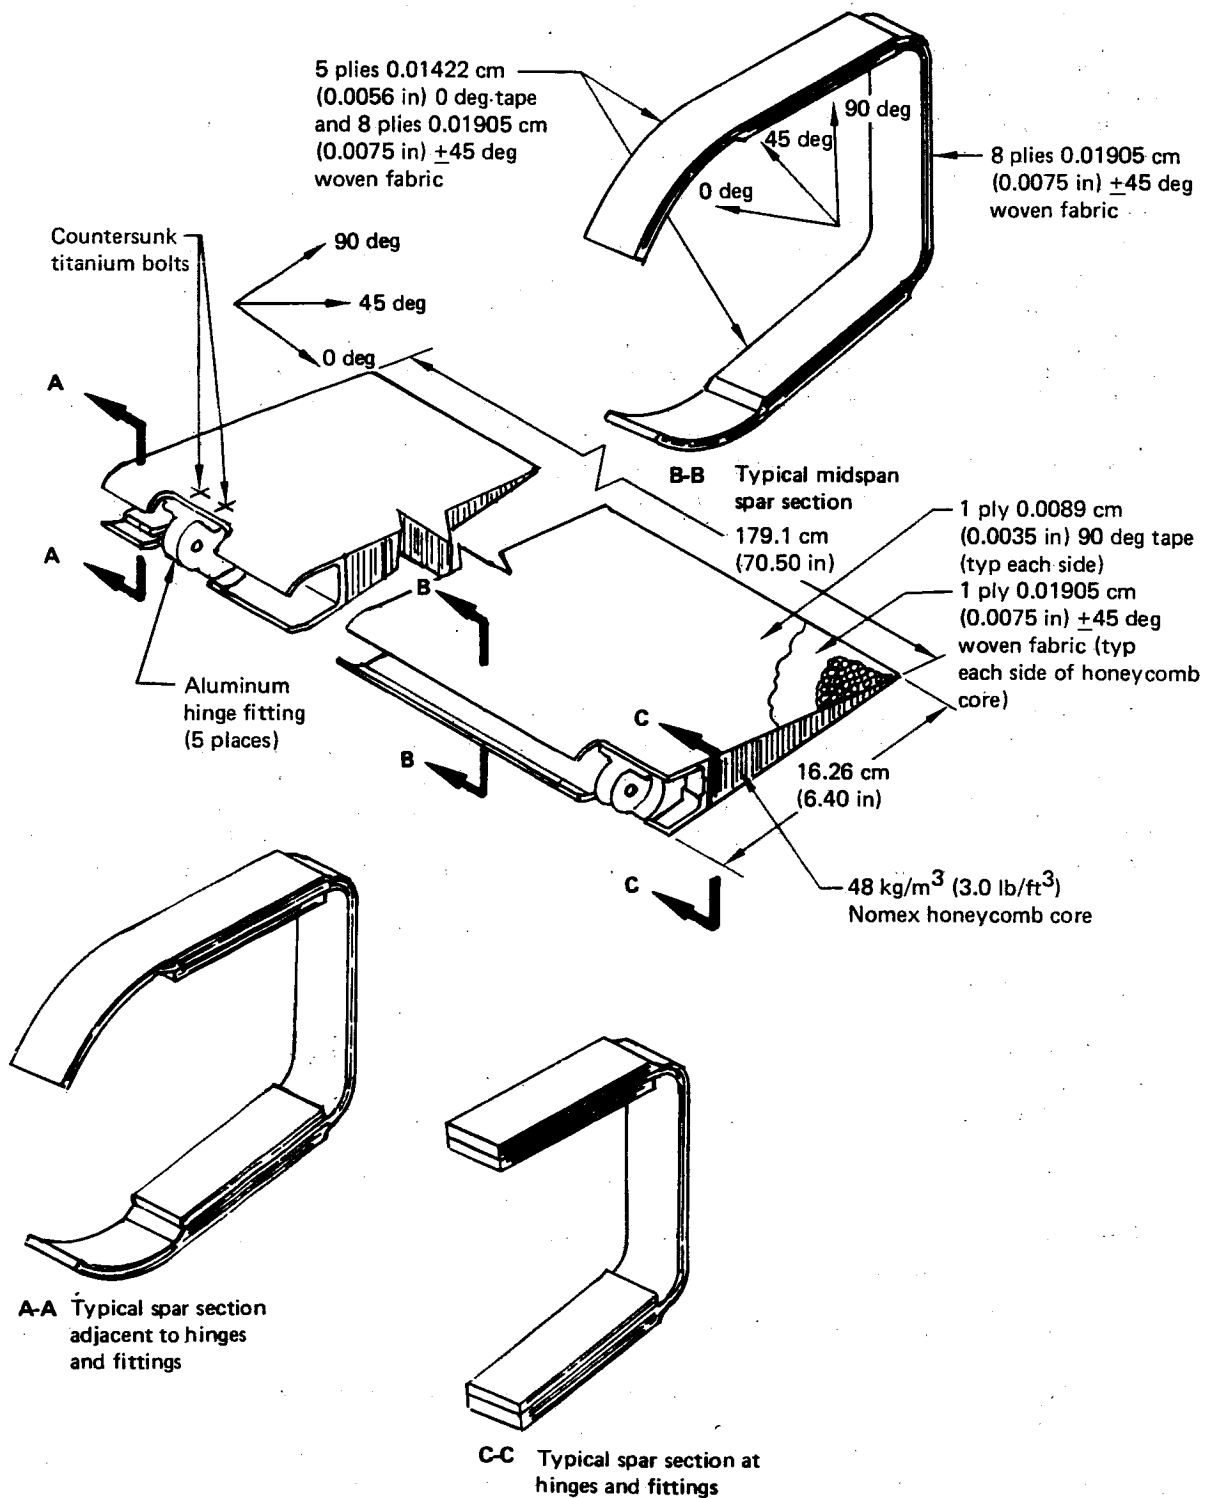
Figure 16. Control Tab

The control tab is a lightweight graphite-epoxy wedge-shaped structure with minimum-thickness face sheets (one ply +45-deg graphite-epoxy fabric 0.01905-cm (0.0075-in) thick plus one ply 90-deg graphite-epoxy unidirectional tape 0.0089-cm (0.0035-in) thick) supported by full-depth 0.318-cm (0.125-in) cell, 48-kg/m³ (3.0-lb/ft³) Nomex honeycomb core, and a laminate spar (fig. 16). The five aluminum hinge fittings used on the aluminum tab were retained. One hinge was relocated spanwise to preclude interchangeability with the current aluminum tab, since elevators are a controlled mass-balanced surface.

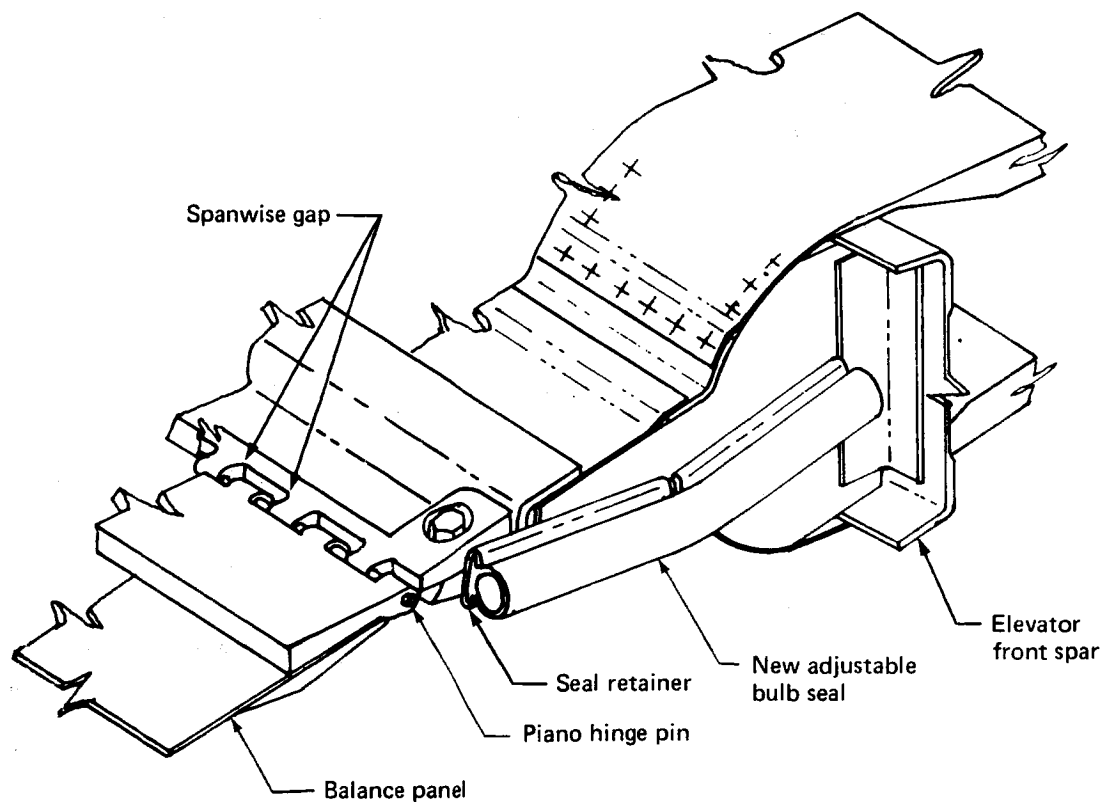
Figure 17. Adjustable Seals and Piano Hinge

- Aerodynamic sealing of balance panels to the sides of the stabilizer hinge ribs. New, larger diameter bulb seals and new seal retainers were required to maintain this seal throughout the range of elevator operating temperatures (fig. 17).

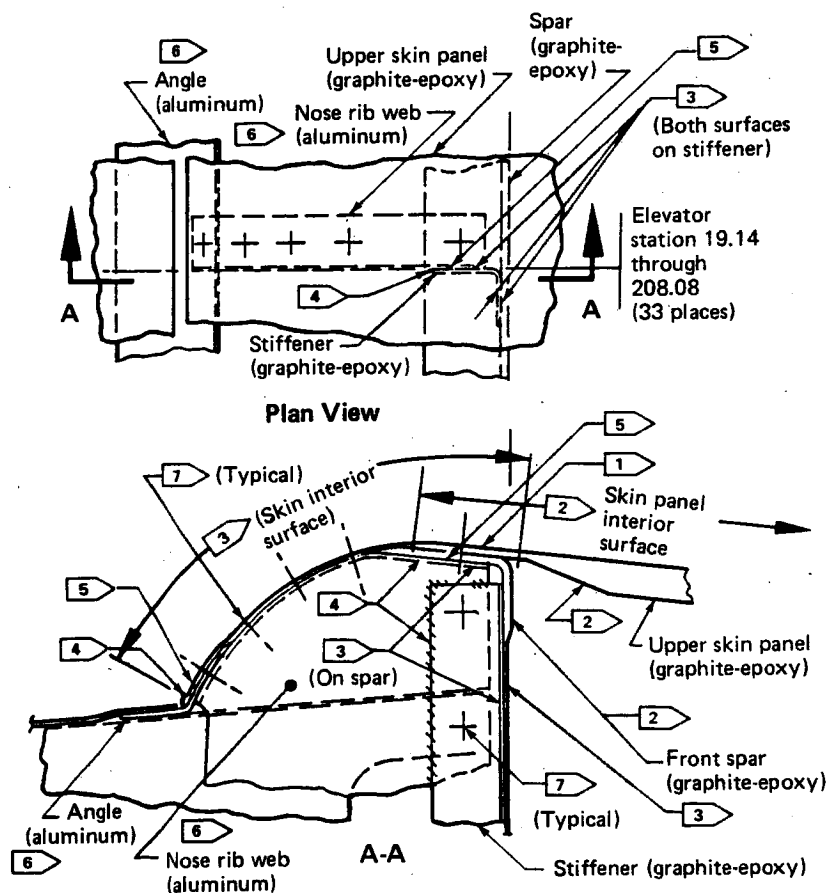
Figure 18. Corrosion Protection—Typical Graphite-Epoxy/Aluminum Interface

The corrosion protection system selected consisted of covering graphite-epoxy surfaces with a ply of cocured fiberglass or Tedlar in areas that are within 7.62 cm (3 in) of aluminum or interface with aluminum structure. Also, a polysulfide faying-surface seal was applied between the graphite-epoxy part and the aluminum part. Fasteners were installed with wet polysulfide sealant, and exposed graphite-epoxy edges adjacent to aluminum structure were fillet sealed. In addition to the isolation of graphite-epoxy surfaces from aluminum structure, all aluminum structure was primed and painted with an enamel paint. An example of the corrosion protection system is detailed in Figure 18.

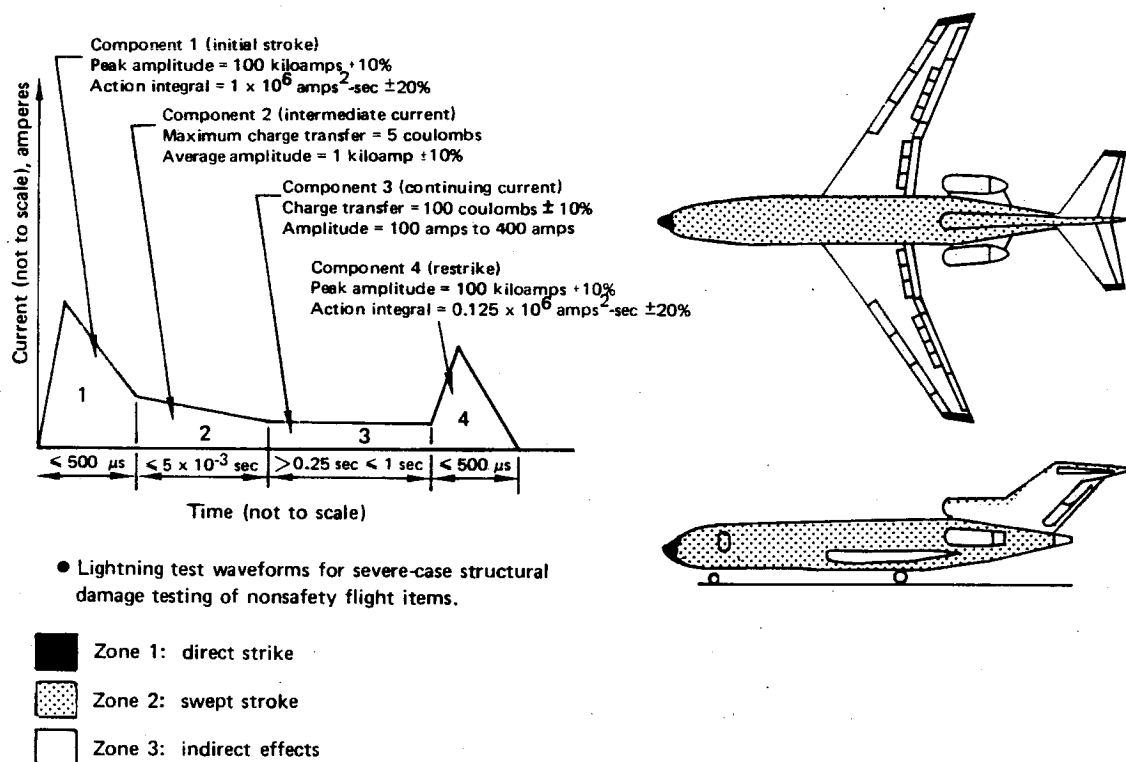
Figure 19. Lightning Strike Zones and Intensities

Figure 19 defines the potential lightning threat, as defined by SAE Committee AE4L (ref 4), that shall be accounted for in the protection system design.

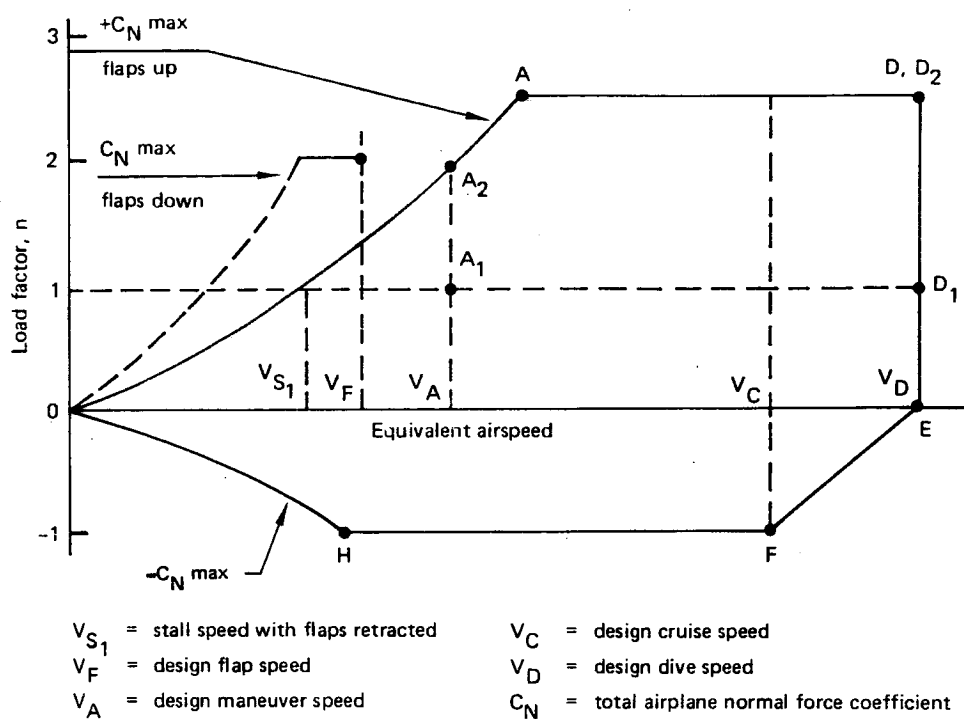
Figure 20. CAR 4b V-n Diagram

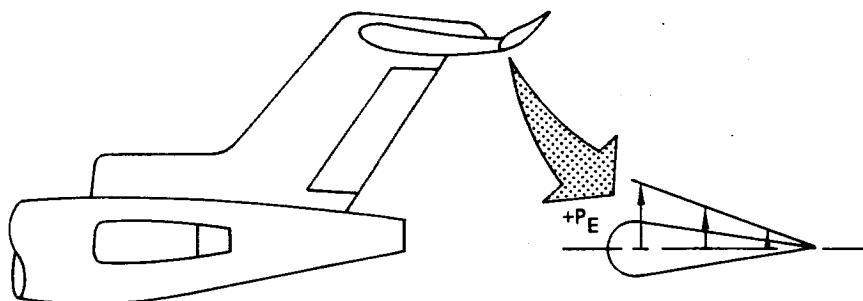
Condition	Load case	Limit load factor	Altitude, m (ft)	Speed, km/hr (kn)	Ultimate pressure P_E , kPa (lbf/in ²)
+ Maneuver at V_D	120R	2.5	4145 (13,600)	851 (460)	-23.37 (-3.39)
- Maneuver at V_D	122R	-1.0	Sea level	722 (390)	23.31 (-3.38)
Check maneuver	124	1.0	Sea level	722 (390)	-2.76 (-0.40)
Instantaneous elevator	125	1.0	Sea level	463 (250)	-22.62 (-3.28)
+ Maneuver at V_D	128	2.5	Sea level	851 (460)	-31.85 (-4.62)

Figure 21. Critical Design Conditions

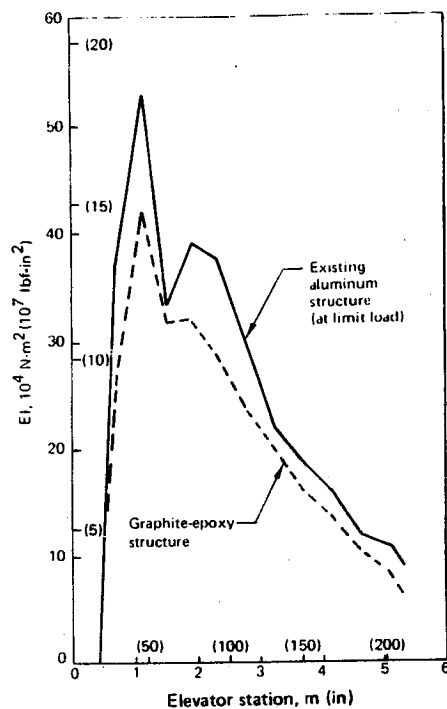
Figure 22. 727 Elevator Spanwise Bending Stiffness

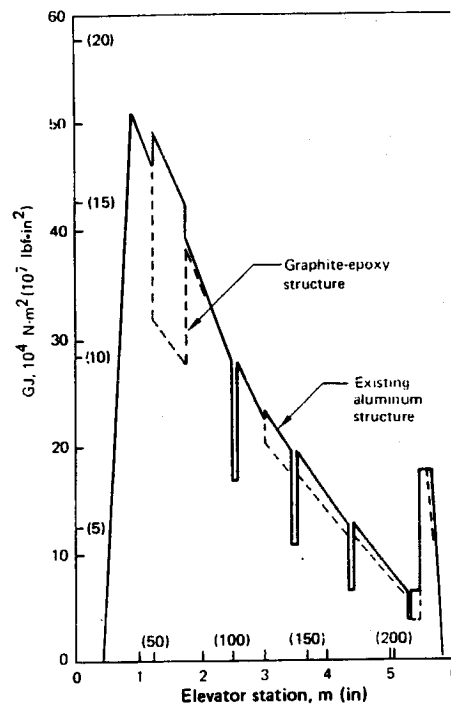
Figure 23. 727 Elevator Torsional Stiffness

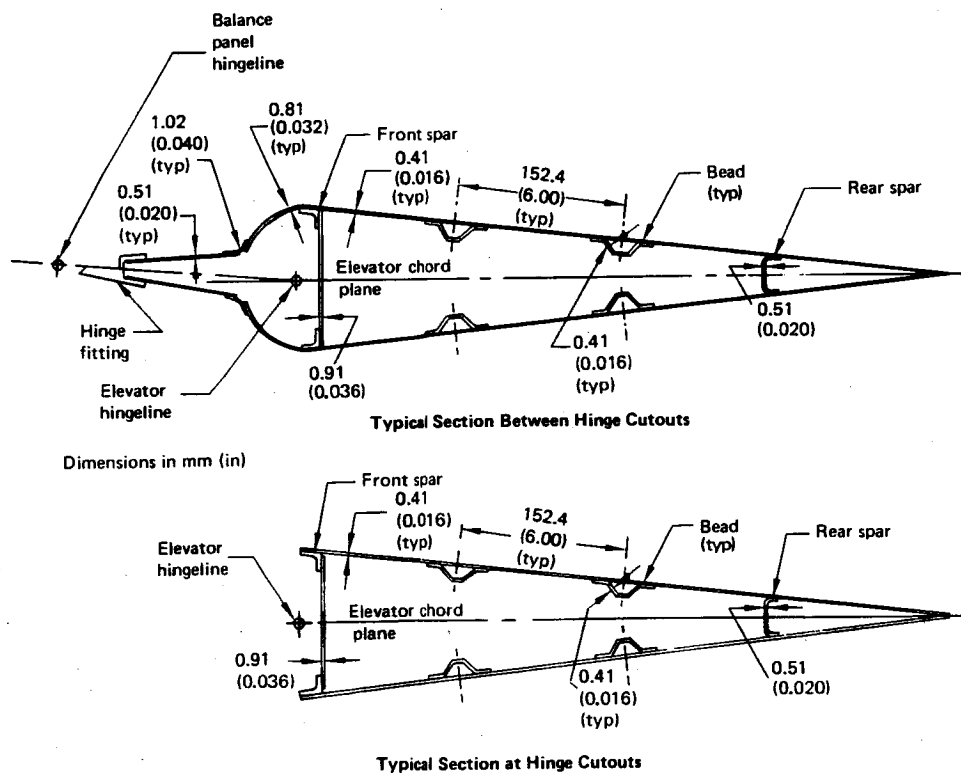
Figure 24. Production Aluminum Elevator
